Landslide and Alluvial Fan Activity Due to Tropical Storm Irene: Examples from Money Brook, Black River Watershed, VT

*GSA Northeastern Section 50th Annual Meeting
Bretton Woods, New Hampshire
23 March 2015*

Kristen L. Underwood, South Mountain R&CS, Bristol, VT
George Springston, Norwich University, Northfield, VT

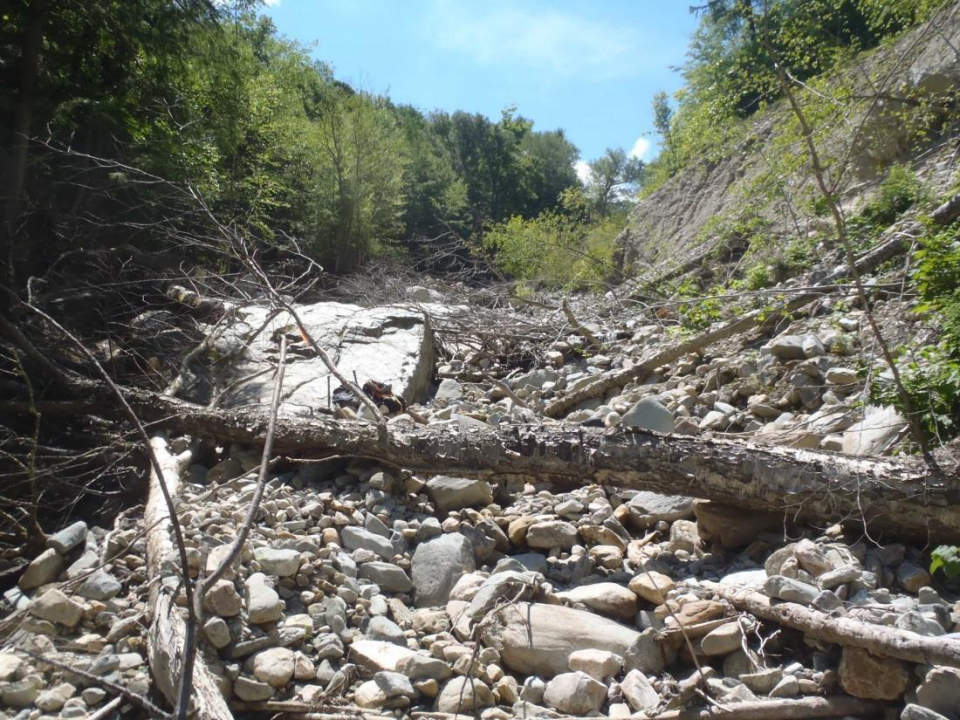
Left: Looking upstream at MB-10. Bedrock can be seen on the left side of the photo (on the right side of the channel).

Right: Looking downstream at MB-10. Note abundant boulders, the source material for the boulders on the alluvial fan.

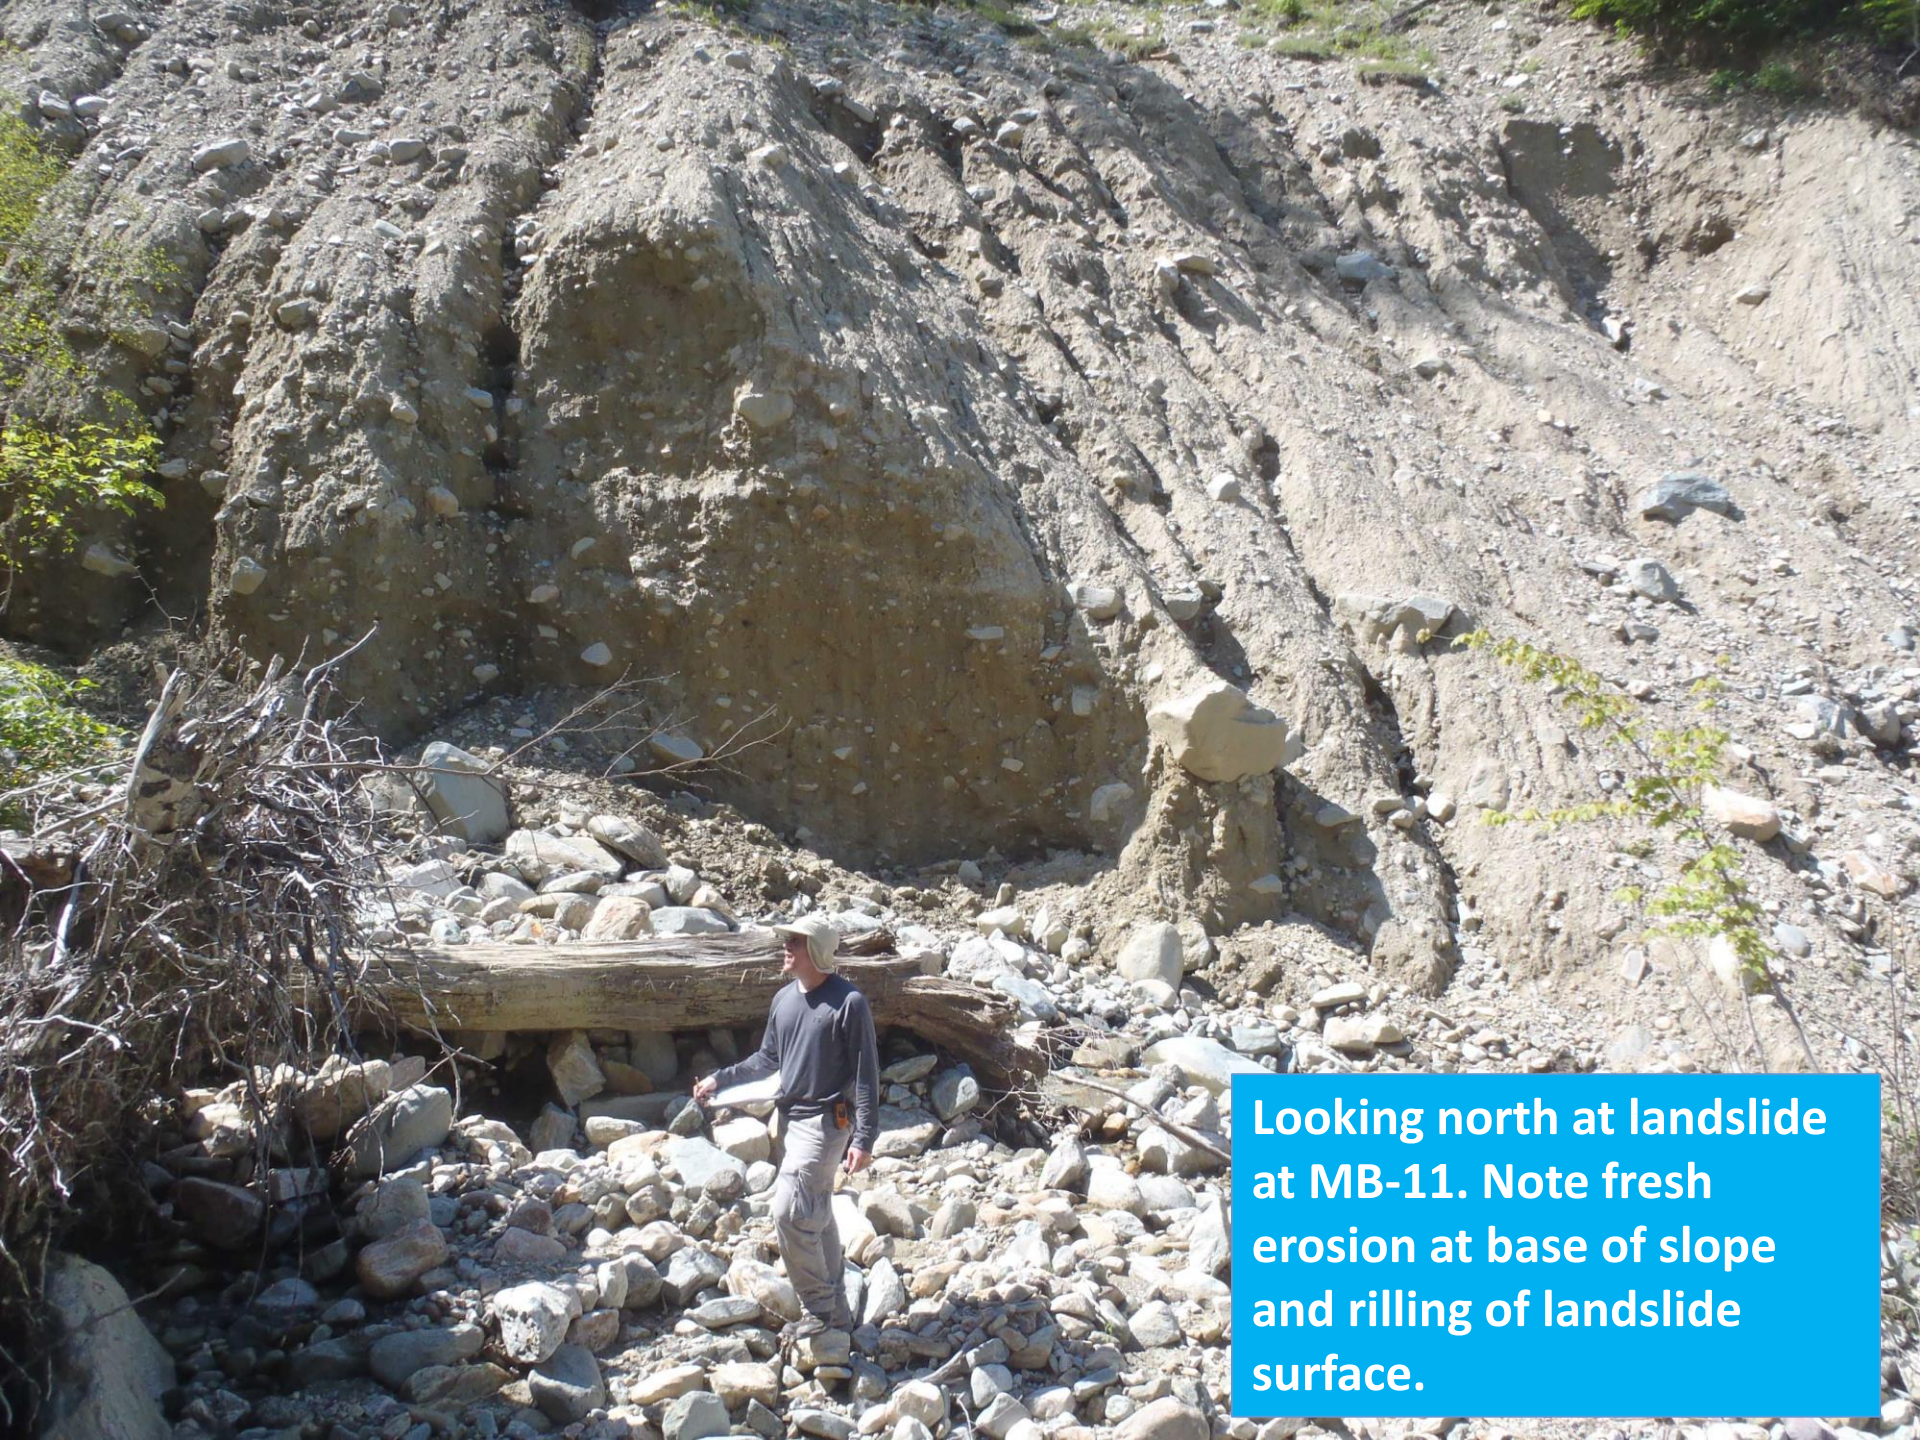
Looking north at landslide at MB-11. Note fresh erosion at base of slope and rilling of landslide surface.
