Black River, Lake Rescue and Money Brook TS Irene Short and Long-term Impacts

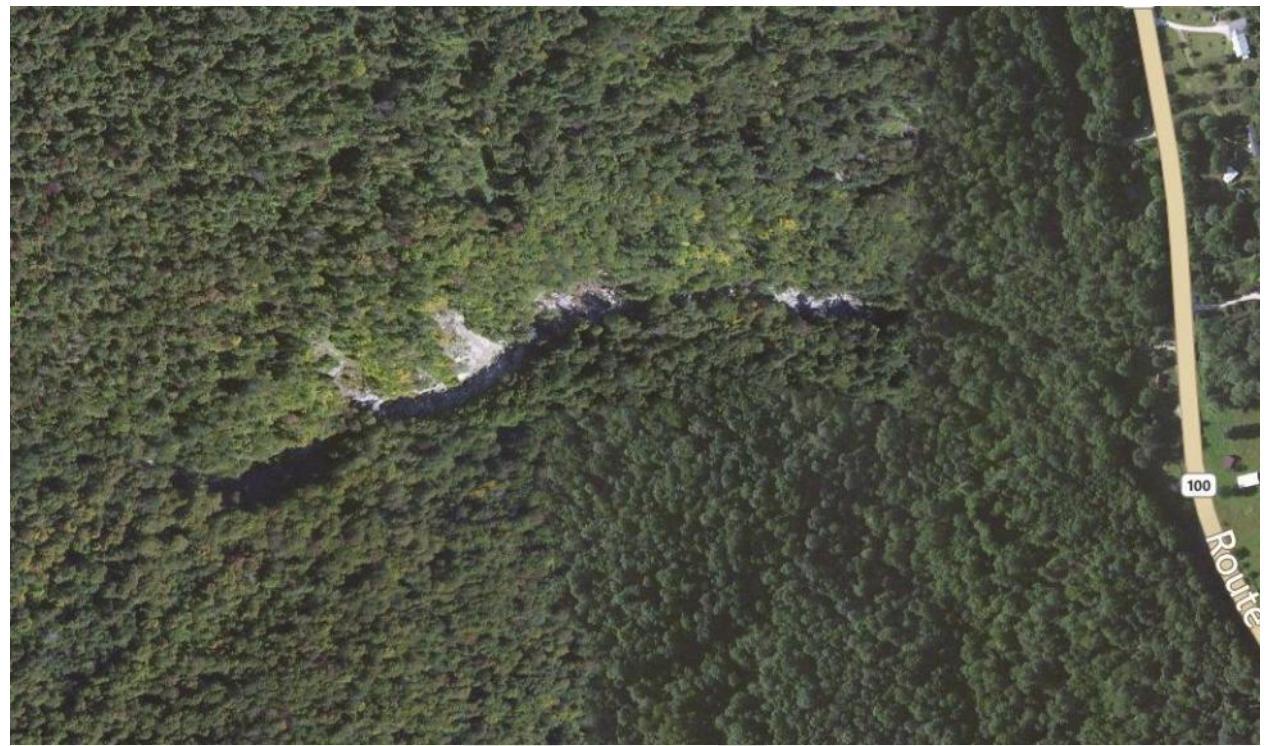
Money Brook mass failure before TS Irene (Bing.com)

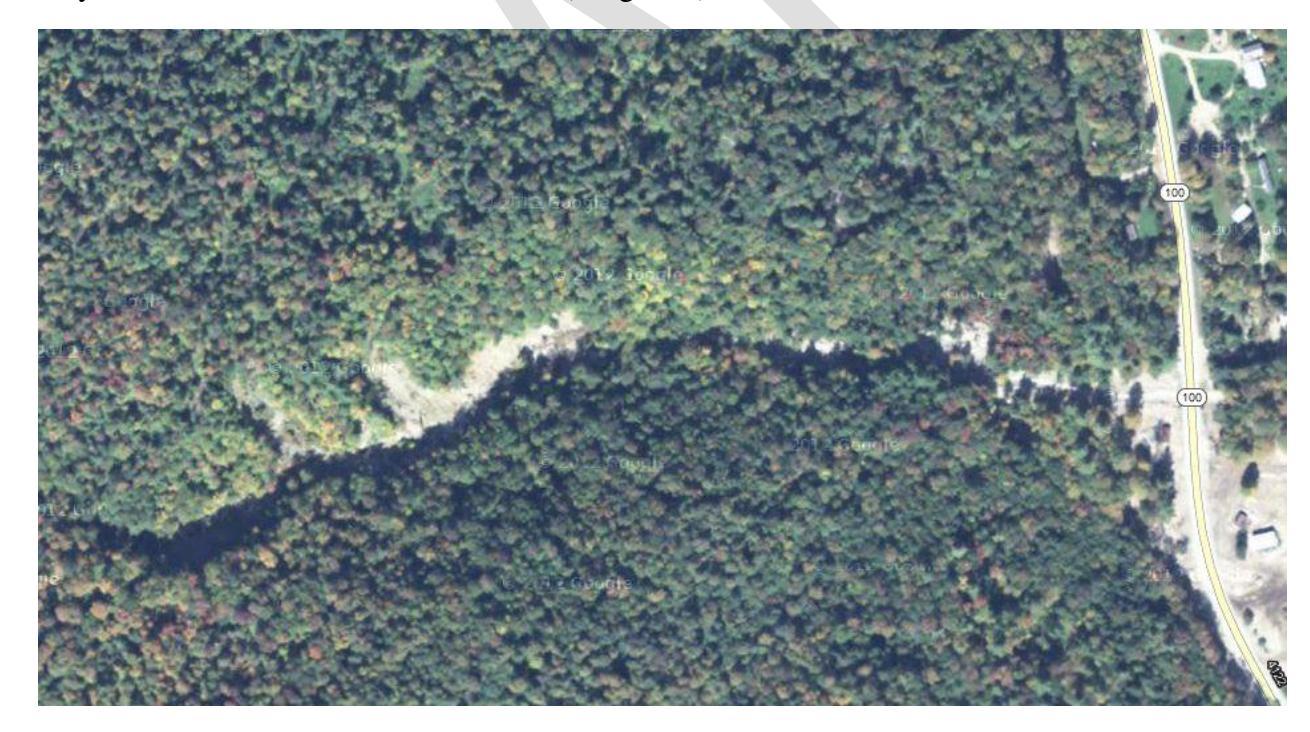
Money Brook crosses Route 100 one mile south of the Rte. 100A junction (-72.73168, 43.51571) and enters the Black River just east of this point. Approximately 1/3 mile upstream from Route 100 a mass failure, a large streambank slide, has existed for some years. TS Irene exacerbated this slide releasing massive amounts of sediment into the Black River system. As the brook waters reached the undersized Route 100 crossing, it buried the road in rubble and carried volumes of water and sediment onto Pingree Flats.

Money Brook mass failure after TS Irene (Google.com)

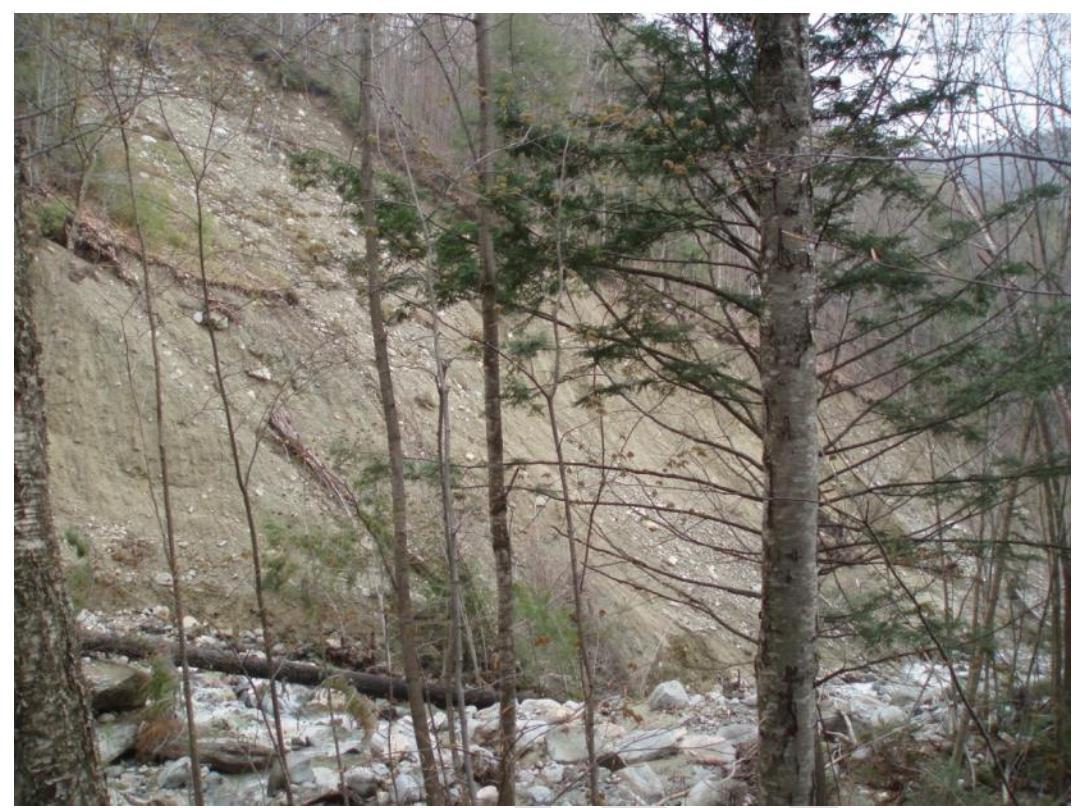
The mass failure on Money Brook was evaluated by Watershed Management Division staff on April 24, 2012. The mass failure slump is estimated to be 800 - 1000 feet long and 75 - 100 feet high. The slope of the failing bank is nearly vertical in places.

The slide area is located on the northern slope of the narrow Money Brook valley. From the uppermost extent of the slide to Route 100, the channel slope is over 20%, which is an extremely steep stream slope (for comparison, the slope of the Black River near Pingree Flats is 0.2%).

Options for remediation at the Money Brook slide are limited. The soil material is non-cohesive "Berkshire-Tunbridge complex, 35 to 50 percent slopes, very stony," which is described as gravelly fine sandy loam. Any armoring of the lower portion of the slide, toe stabilization, or carved benches in the slope would be impractical because the work would likely be buried by falling material. Pulling the slope back to a stable grade over such a large area would be prohibitively expensive in such a remote location. Also, stabilization would not be able to address the further gullying happening higher up the slide's face.

Money Brook mass failure - April 2012

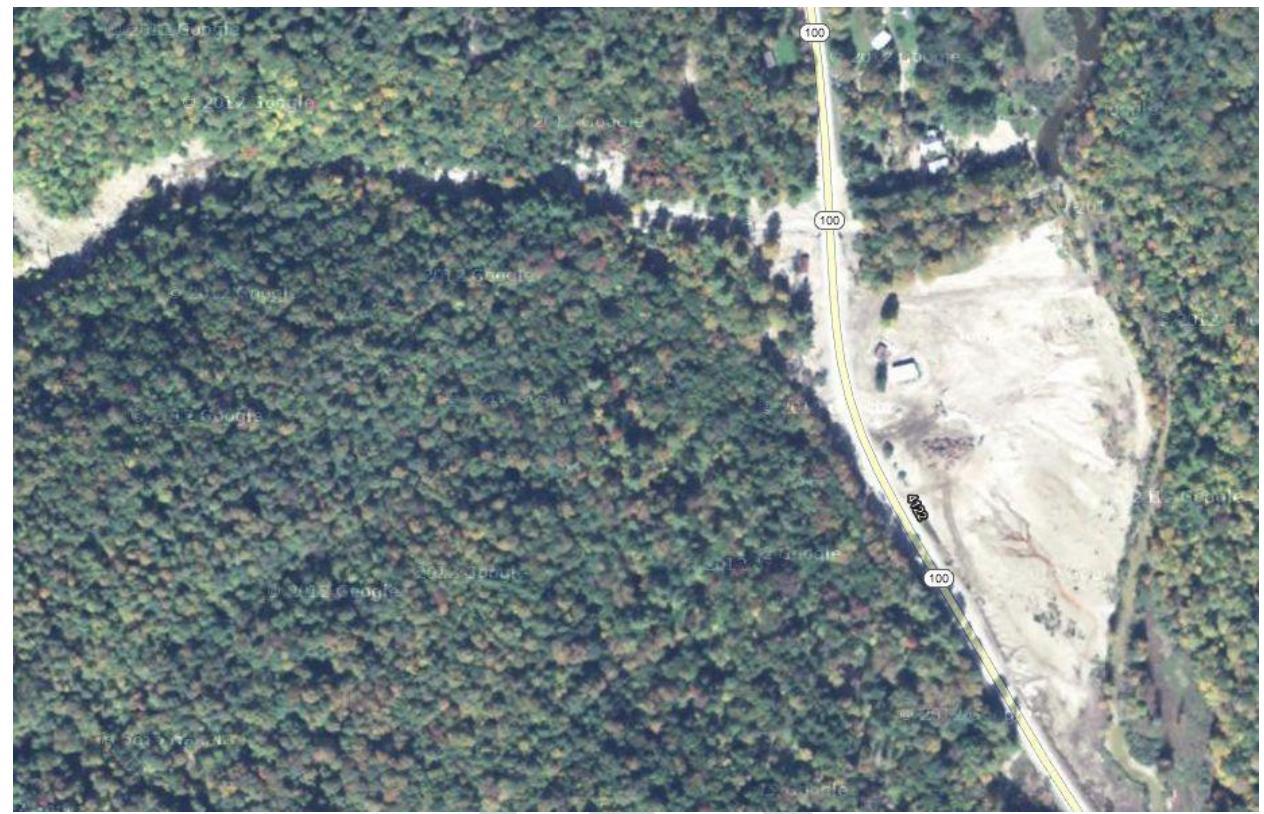
Pingree Flats is located on an alluvial fan—a geologic feature which can occur where a very steep mountain stream transitions abruptly to a flat, broad valley. The sediment (boulders, gravel, sand, etc.) carried by the stream during the storm was transported down the steep slope and dropped right at the Route 100 bridge where the land flattens out, in a "fan" shape of sediment. These flat areas are important from a water quality perspective—if the majority of sediments had not dropped out at this location, they would have continue to move downstream into the Black River and on into the lakes below. Stream paths can often dramatically shift locations in alluvial fan areas. Because this natural process happens in an episodic way (decades can pass between times when the sediment dumping occurs), people tend to live on alluvial fans, because they appear to be desirable flat ground for building.

Money Brook & Pingree Flats Post-Irene

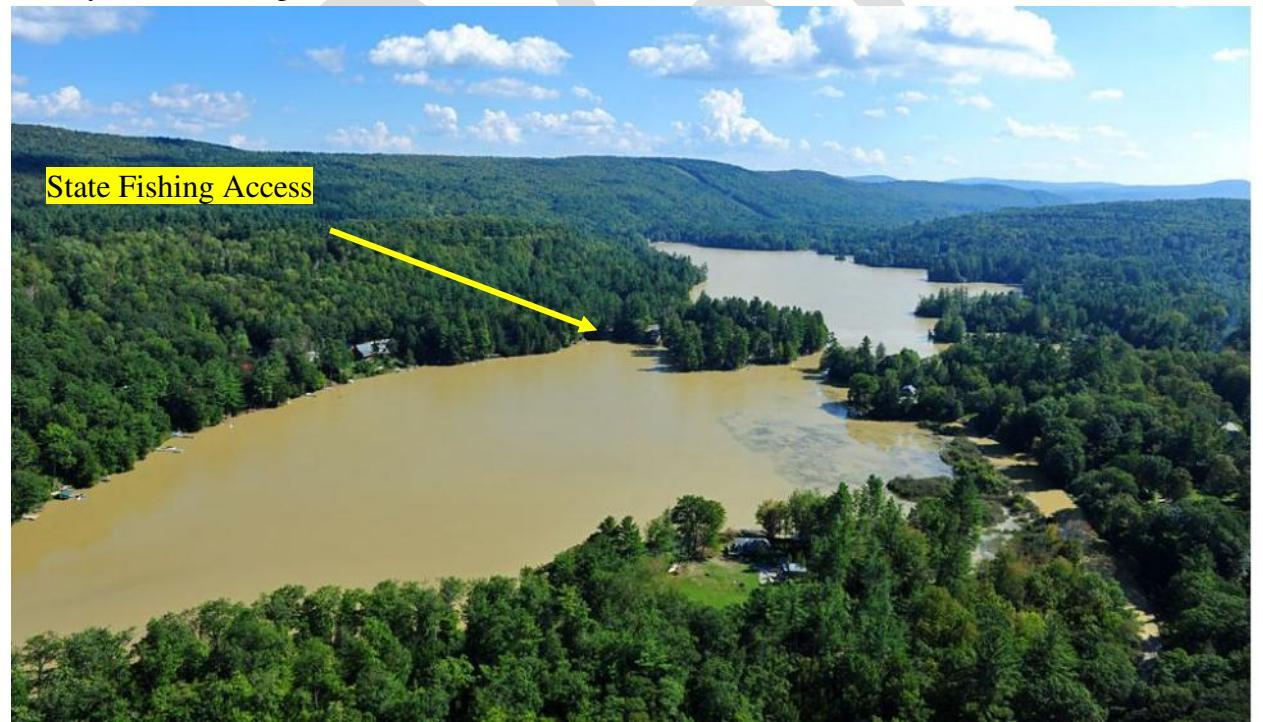
The lake system is acting as a sediment basin with the results most evident in Lake Rescue. Newly deposited sandbars reach the surface in some areas, the main navigation channel connecting Round Pond, the northern end of Lake Rescue, with the main lake is shallow enough to cause boat grounding and water access to some homes is now limited to non-motorized boats. The State Fish and Wildlife fishing access located on Round Pond has been cleaned and continues to offer recreational access to lake users.

Round Pond leading into Lake Rescue post-Irene, September 2011 (VT AOT)

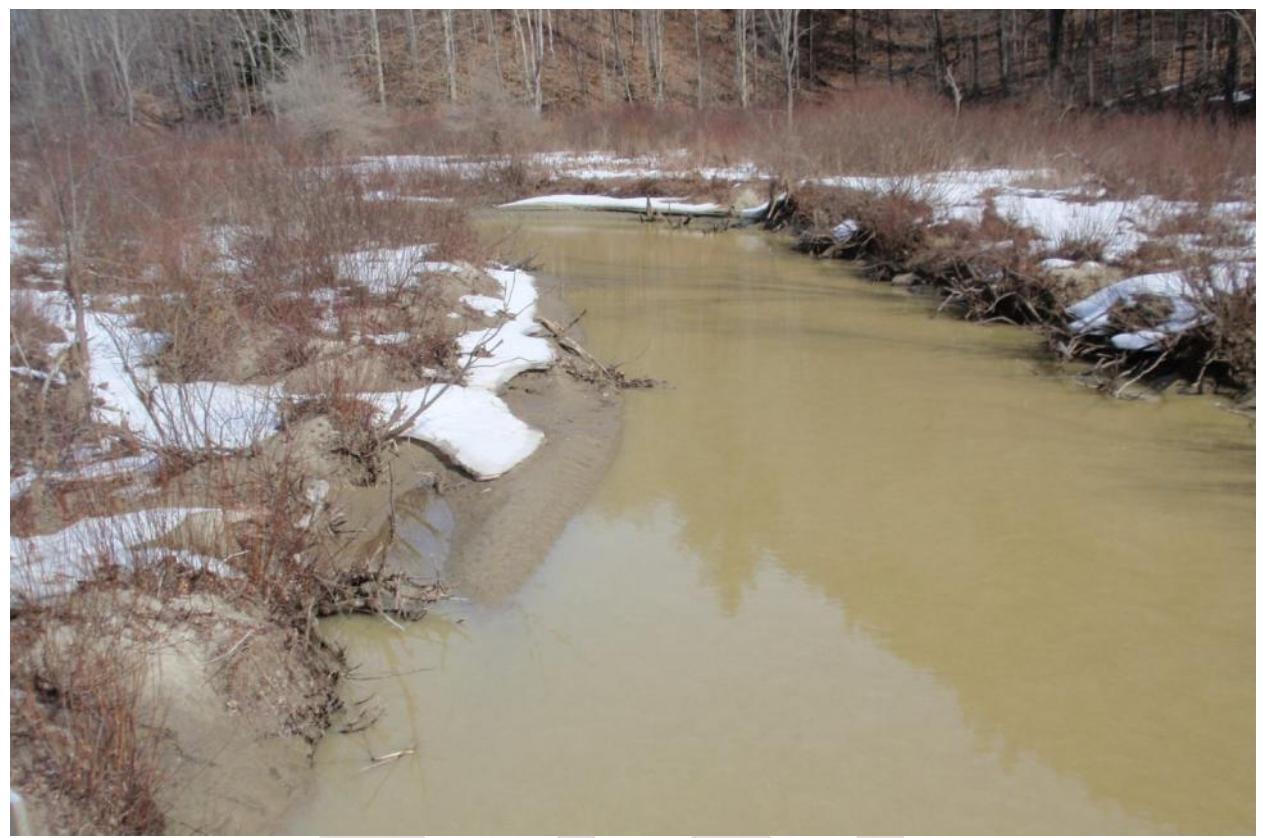
The water in Money Brook remains brown following any rains and continues to carry a high sediment load into the Black River a full year after the storm. Today the water in the Black River above Money Brook usually runs clear unless there is precipitation. While the sediment deposited on Pingree Flats remains a concern as heavy rain or flooding may transport this load to the river, Pingree Flats is acting as a sediment storage area capturing the material transported to it during the flood and preventing it from reaching the lakes. If the site is allowed to re-vegetate, sediment will be less likely to move off site. If the former wetland features of the flats were restored additional capture of material moving down Money Brook will in all likelihood take place.

Black River below Pingree Flats, March 2012

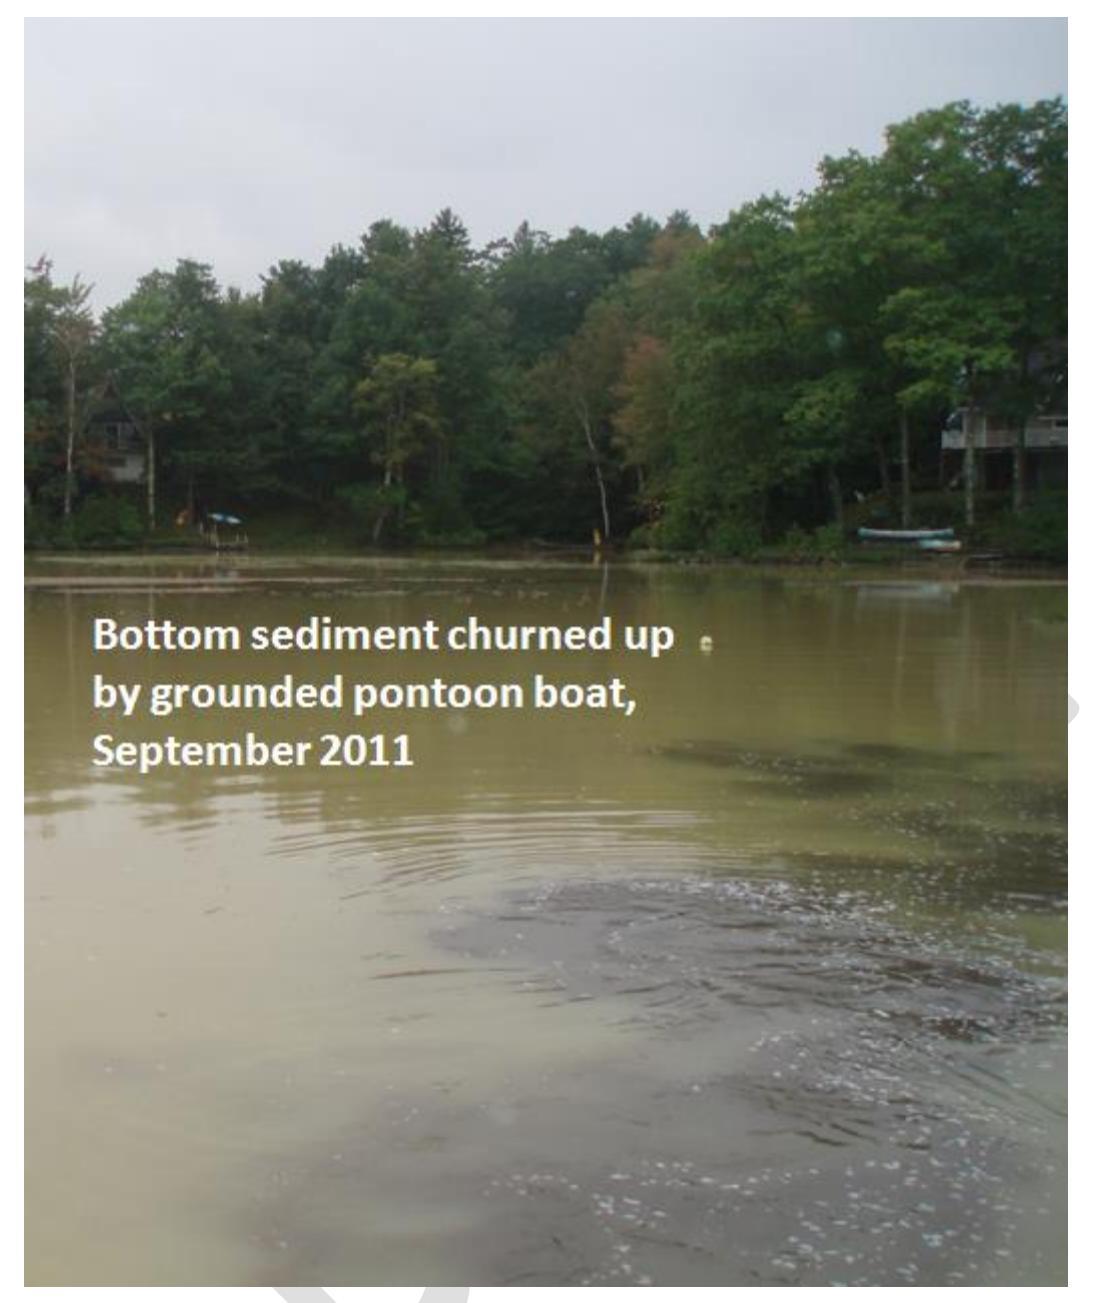
Main navigation channel between Round Pond and Lake Rescue

Re-establishing navigable channels is a priority for the Lake Rescue Association (LRA). LRA is actively pursuing permits for dredging the main channel between Round Pond and Lake Rescue to ensure boating access for recreation and to reduce the hazards posed by shallow waters to boaters and skiers. Camp Plymouth State Park on Echo Lake is also pursuing dredging to re-establish the beach area.
