Landslide and Alluvial Fan Activity Due to Tropical Storm Irene: Examples from Money Brook, Black River Watershed, VT

*GSA Northeastern Section 50th Annual Meeting
Bretton Woods, New Hampshire
23 March 2015*

Kristen L. Underwood, South Mountain R&CS, Bristol, VT
George Springston, Norwich University, Northfield, VT

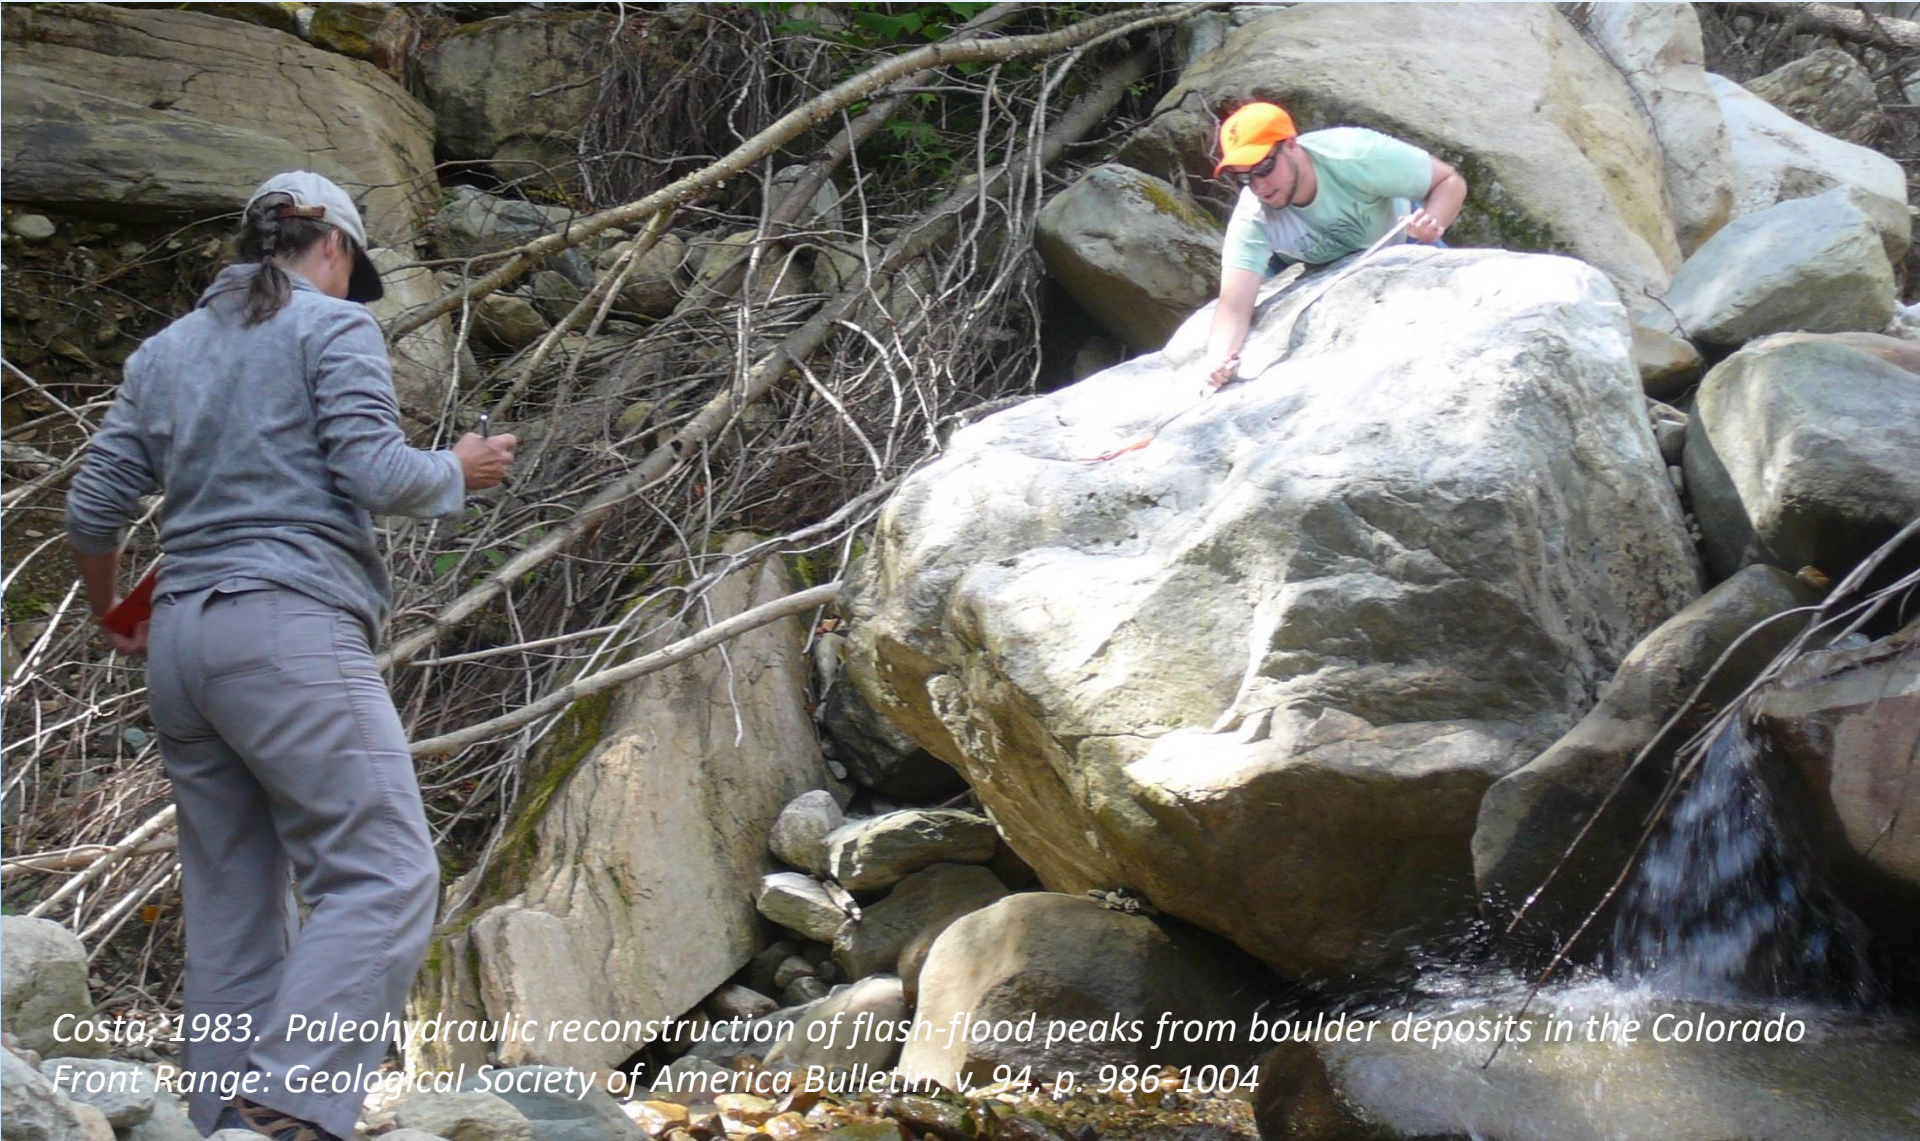
Flood Competence Estimates (after Costa, 1983)

- 7.5 m/s (25 ft/sec) peak velocity during TS Irene

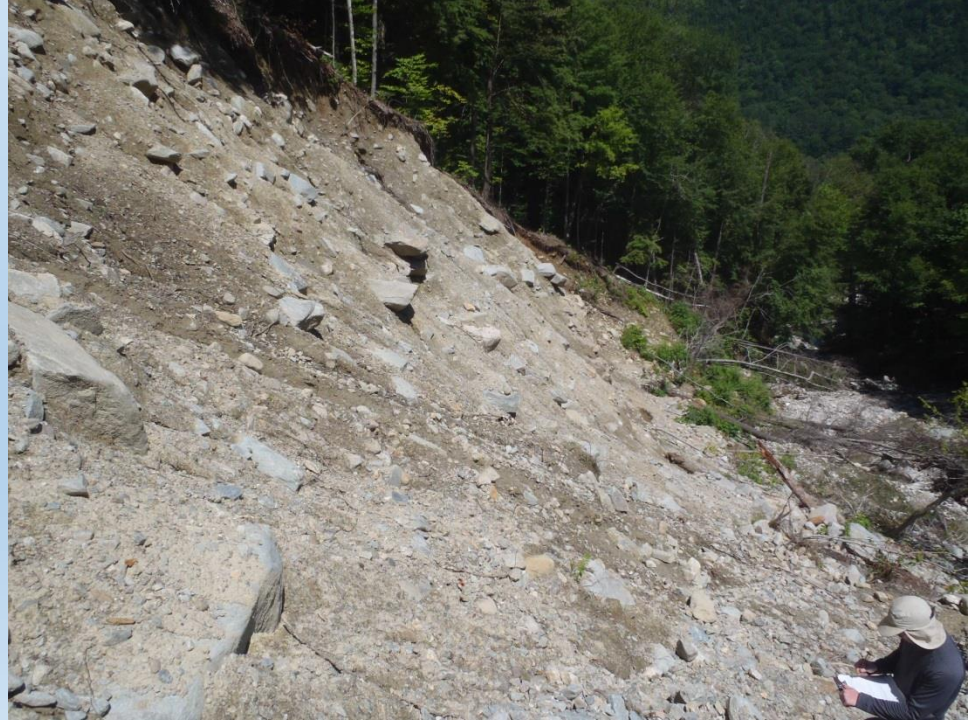
General Characteristics of Major Landslides at Money Brook

Landslide Site	Elevation of Crown (feet)	Activity	Landslide Type	Width (m)	Height (m)	Depth (m)	Aspect	Overall Slide Angle	Area Estimate (sq. m.)
MB-8	1490	Active	Complex	44.0	17.9	>3	175	46	>1000 sq. m.
MB-10	1605	Active	Complex	55.0	28.8	>3	130	37	>1000 sq. m.
MB-11	1755	Active	Complex	92.0	58.3	>3	155	31	>1000 sq. m.
MB-13	1780	Active	Complex	40.0	38.5	>3	176	37	>1000 sq. m.
MB15	1730	Active	Complex	44.0	19.2	<2	303	41	>1000 sq. m.
MB-16	1755	Active	Complex	91.0	18.4	<2	5	40	>1000 sq. m.
Sum				366.0	181.1			232	
Mean					30.2			38.7

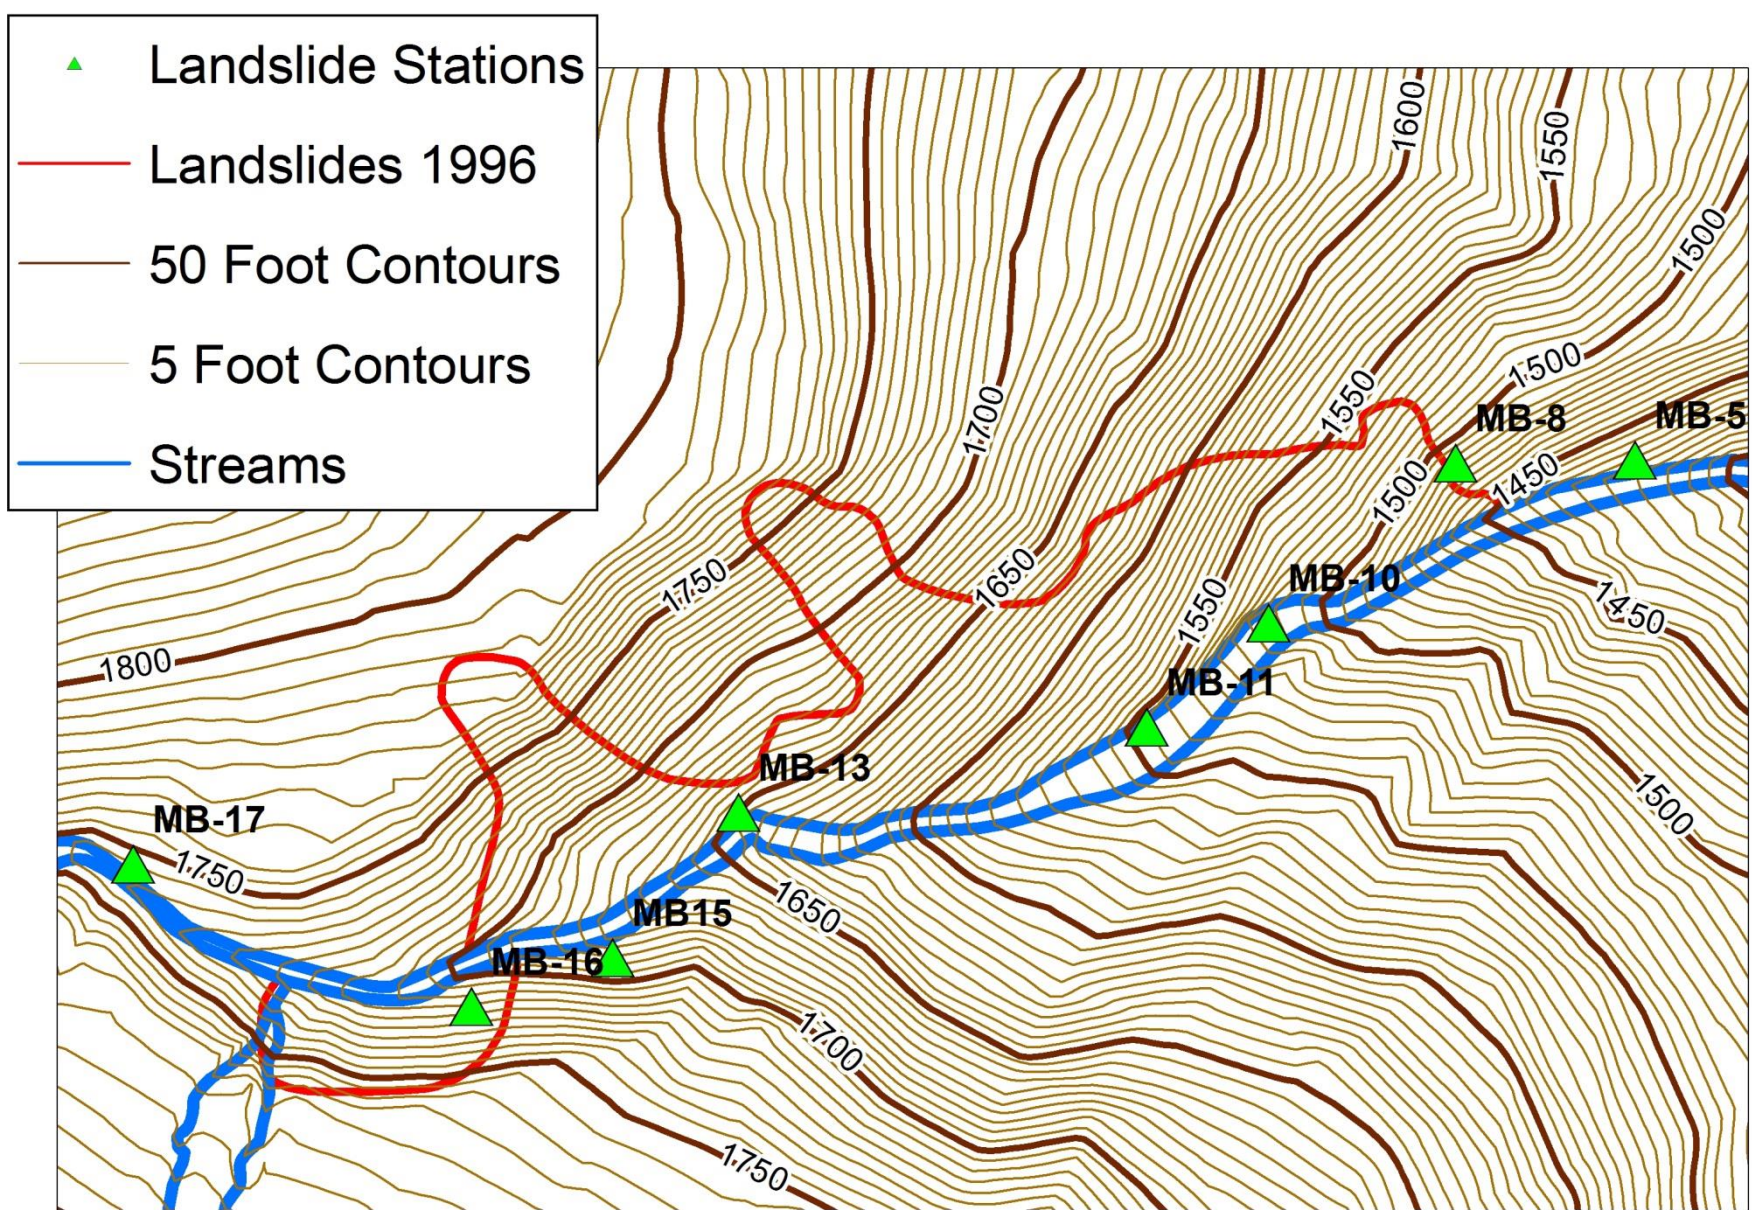
Estimate of Volume Change of Landslides at Money Brook from 1996 to 2012

Landslide Section	Area (sq. ft)	Depth (ft)	Volume (cubic feet)	Volume (cubic yards)
North Side, Lidar	43,551	18.2	792,628	29,356
North Side, No Lidar	76,521	18.2	1,392,682	51,581
South Side, No Lidar	35,113	9.1	319,528	11,834
Sum			2,504,838	92,771

For the landslide on the north side with lidar, depth is measured change in elevation between 1996 and 2012.

This same depth was used for the portion of the north side without lidar.

For south side without lidar, the above figure was cut in half. This is consistent with the observed depth of erosion at this landslide.

**Total estimate for landslide volume
change = 92,772 cubic yards (71,100 m³)**

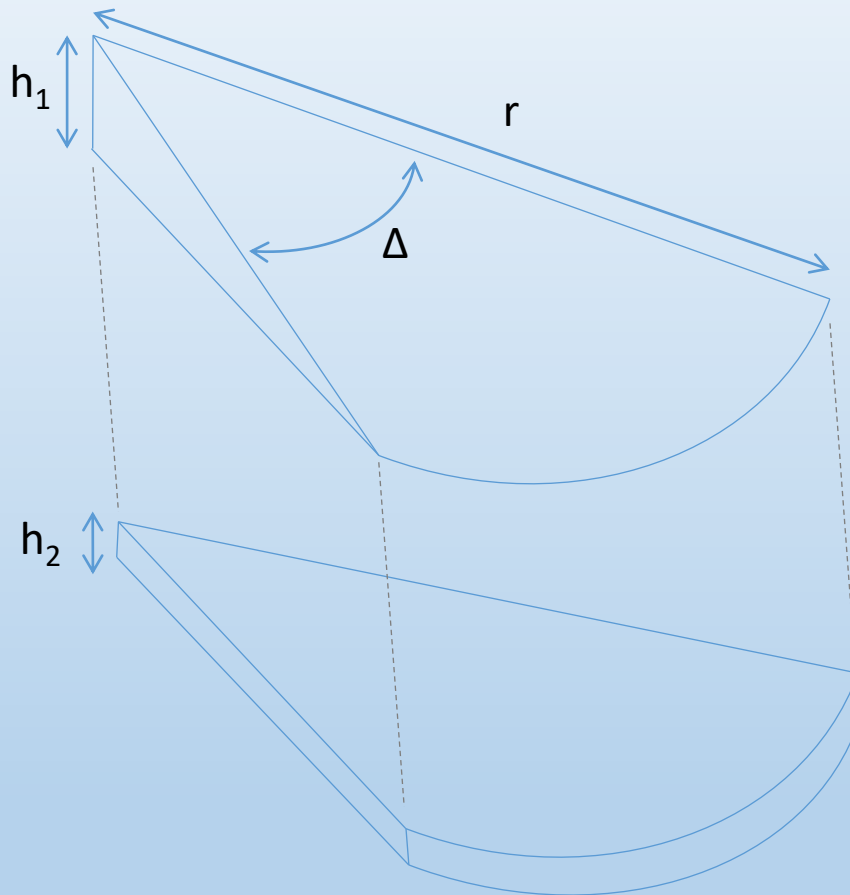
Estimate of Volume of Material Deposited on Money Brook Alluvial Fan

**Total volume estimate for deposit on fan = 1,989,800
cubic feet = 73,696 cubic yards (56,600 m³)**
